Ohio Home Inspection

Property Inspection Report

Client(s): **John Q Public**
Property address: **123 Main Street**
Cleveland, OH
Inspection date: **Monday, September 7, 2020**

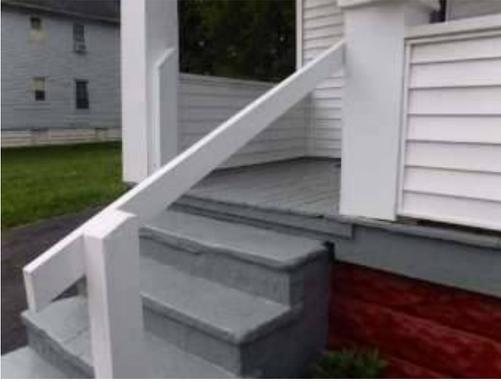
Photo 3-1

One or more handrails had no returns installed, where ends of handrails turn and connect to adjacent walls so objects or clothing will not catch on the open ends. This is a safety hazard. Recommend that a qualified person install returns per standard building practices.

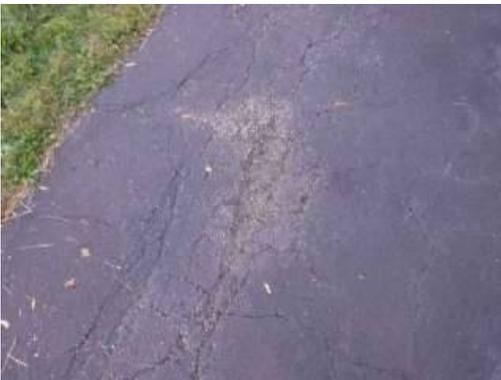
Photo 4-1

The asphalt driveway surface was worn and is prone to developing cracks from water penetration. Recommend that a qualified person reseal the driveway. For more information, visit:

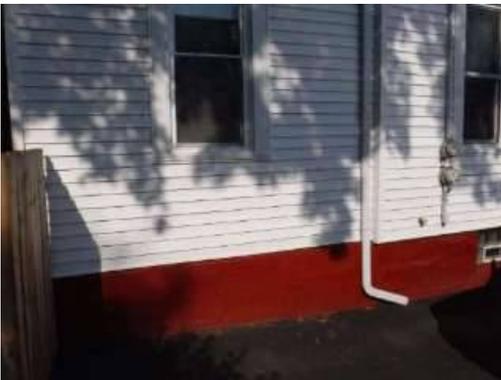
Photo 5-1

It's beyond the scope of a home inspection to determine if these drains flow adequately during prolonged periods of heavy rain. Recommend consulting with the property owners about this if possible, and monitoring drains in the future. If water is found to accumulate, then recommend that a qualified contractor evaluate and repair as necessary. For example, by cleaning, repairing or installing drains.

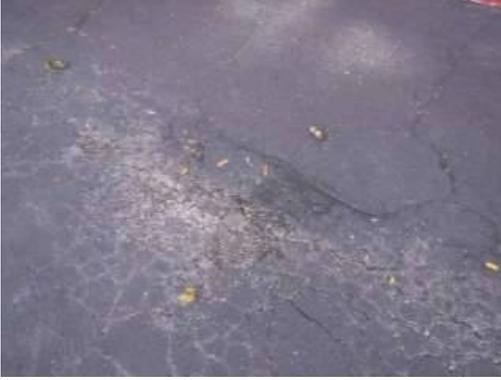
Photo 6-1

Minor deterioration (e.g. cracks, holes, settlement, heaving) was found in the driveway, but no trip hazards were found. The client may wish to have repairs made for cosmetic reasons.

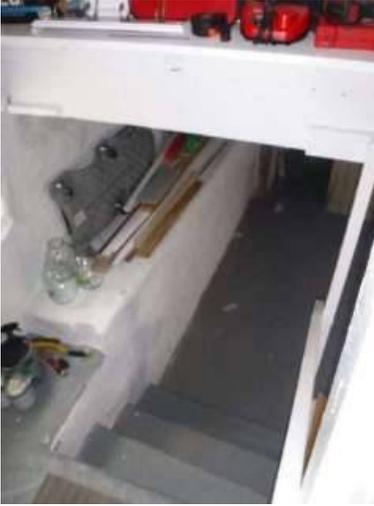
Photo 7-1

The ceiling height over stairs at one or more locations was too low and poses a safety hazard, especially for tall people. Ceilings over stairs should be at least 6 feet 8 inches high. At a minimum, be aware of this hazard, especially when guests who are not familiar with the stairs are present. Recommend that a qualified contractor repair per standard building practices.

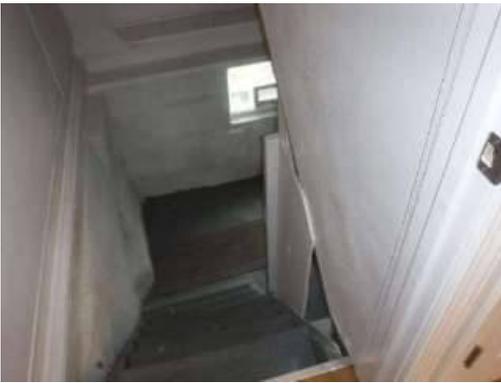
Photo 8-1

Handrails at one or more flights of stairs were missing. This is a potential fall hazard. Handrails should be installed at stairs with four or more risers or where stairs are greater than 30 inches high. Recommend that a qualified contractor install handrails where missing and per standard building practices.

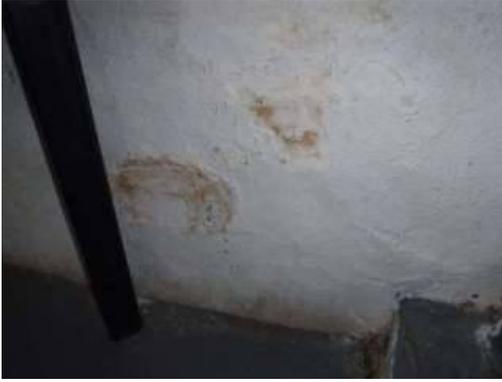
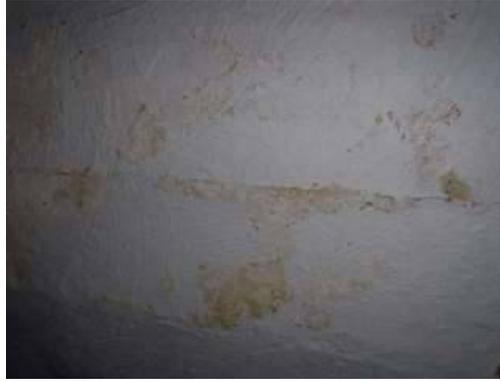
Evidence of prior water intrusion was found in one or more sections of the basement. For example, water stains or rust at support post bases, efflorescence on the foundation, etc. Accumulated water is a conducive condition for wood-destroying organisms and should not be present in the basement. Recommend reviewing any disclosure statements available and ask the property owner about past accumulation of water in the basement. The basement should be monitored in the future for accumulated water, especially after heavy and/or prolonged periods of rain. If water is found to accumulate, then recommend that a qualified contractor who specializes in drainage issues evaluate and repair as necessary. Typical repairs for preventing water from accumulating in basements include:

- Repairing, installing or improving rain run-off systems (gutters, downspouts and extensions or drain lines)
- Improving perimeter grading
- Repairing, installing or improving underground footing and/or curtain drains

Ideally, water should not enter basements, but if water must be controlled after it enters the basement, then typical repairs include installing a sump pump.

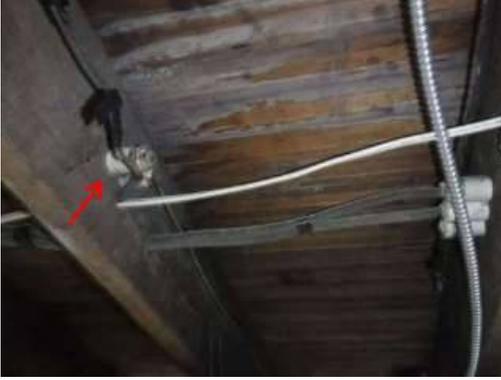
Photo 16-1

"Knob and tube" wiring or related components such as porcelain insulators were found. This type of wiring was commonly installed prior to 1950. It is ungrounded, and considered unsafe by today's standards. Over time, the wire's insulation can become brittle and fall apart or wear thin, resulting in exposed conductors and a risk of shock and/or fire. This wiring is also easily damaged by covering it with insulation (a common practice), and incorrectly tapping new wiring into it.

The inspector did not find any energized knob and tube wiring during the inspection. However, this is no indication that all the knob and tube wiring has been abandoned. It is not within the scope of this inspection to determine what percentage of this property's wiring is of the knob-and-tube type, or to determine what percentage of the knob and tube wiring is energized versus abandoned. Recommend that a qualified electrician evaluate this wiring and make repairs or replace wiring as necessary.

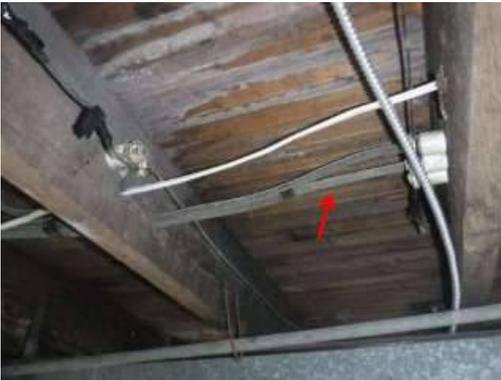
Photo 17-1

Thermal insulation was in contact with "knob and tube" wiring. Many municipalities prohibit this practice for the following reasons:

- Thermal insulation traps the heat created by current, and can cause the wiring insulation to degrade and fail.
- Knob and tube wiring is easily damaged. Because wiring is hidden by insulation, someone moving around in an attic can damage the wiring because they can't see it.

Consult with the property owner about the insulation being in contact with the wiring. If no records are available that verify an evaluation by a licensed electrician prior to the insulation's installation, insulation should be moved or removed as necessary, and a qualified electrician should evaluate the wiring and make repairs if necessary. If the local municipality doesn't allow it, then a qualified contractor and/or electrician should repair as necessary. For example, by removing insulation or replacing knob and tube wiring with modern wiring. For more information, visit:

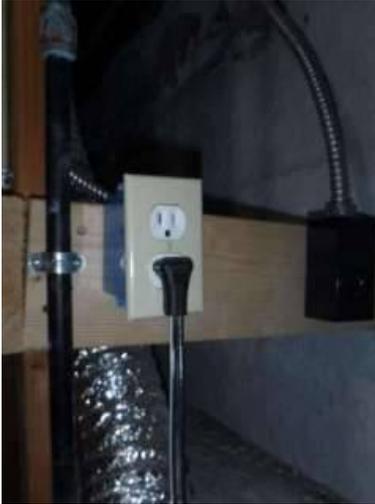
Photo 18-1

One or more electric receptacles at the laundry area and/or exterior had no visible ground fault circuit interrupter (GFCI) protection, or the inspector was unable to determine if GFCI protection was present. If not GFCI-protected, receptacles in wet areas pose a shock hazard. Recommend that a qualified electrician evaluate and install GFCI protection if necessary and per standard building practices. General guidelines for GFCI-protected receptacles include the following locations:

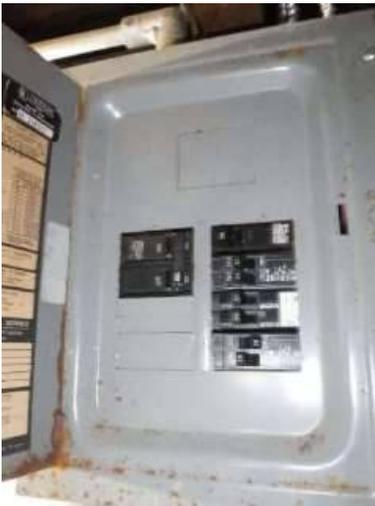
Photo 19-1

The electric service was configured so that too many hand movements were necessary to turn off all power for the service. Six or fewer circuit breakers should be required to turn off all power to a residence. This is a potential safety hazard during an emergency when the power needs to be turned off quickly. Recommend that a qualified electrician repair per standard building practices.

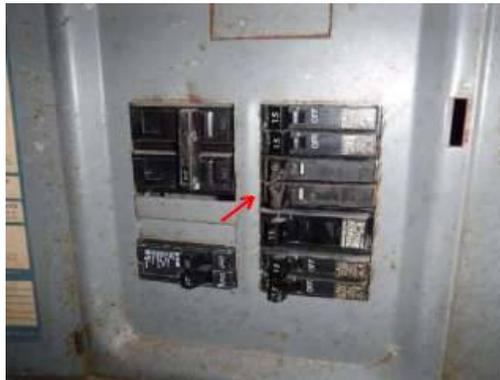
Photo 19-2 circuit breaker damaged

One or more circuit breakers in panel(s) # were broken or damaged. This is a potential shock or fire hazard. Recommend that a qualified electrician replace circuit breakers and make repairs as necessary.

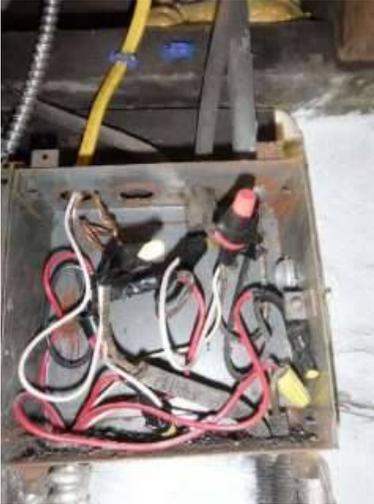
Photo 21-1

Bare wire ends, or wires with a substandard termination, were found at one or more locations. This is a potential shock hazard. Recommend that a qualified electrician repair as necessary. For example, by cutting wires to length and terminating with wire nuts in a permanently mounted, covered junction box.

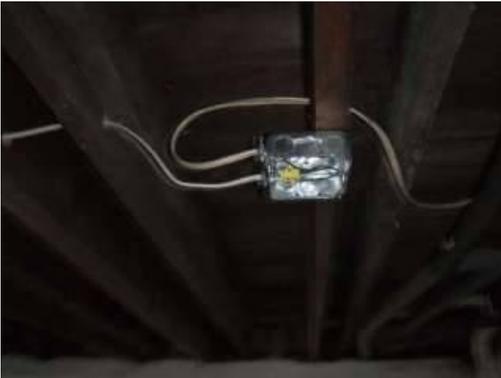
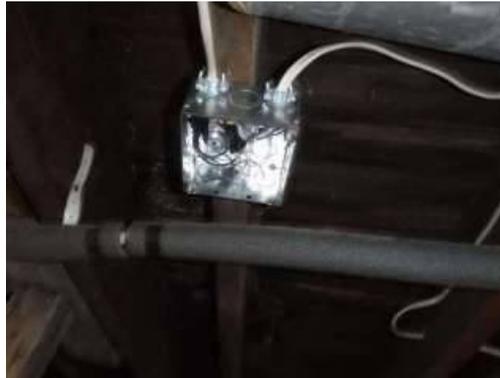
One or more cover plates for switches, receptacles or junction boxes were missing or broken. These plates are intended to contain fire and prevent electric shock from occurring due to exposed wires. Recommend that a qualified person install cover plates where necessary.

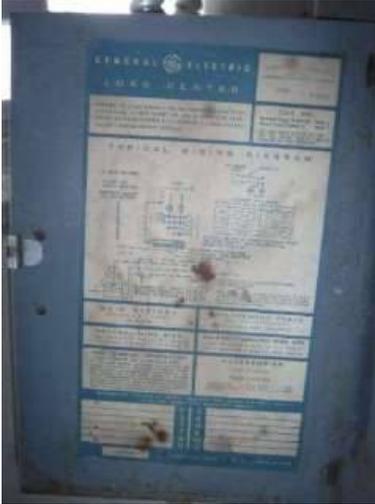
Photo 25-1

The legend for circuit breakers or fuses in panel(s) #A and B was missing, incomplete, illegible or confusing. This is a potential shock or fire hazard in the event of an emergency when power needs to be turned off. Recommend correcting the legend so it's accurate, complete and legible. Evaluation by a qualified electrician may be necessary.

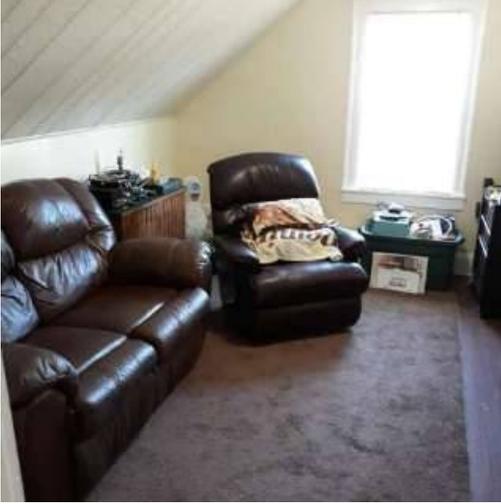
One or more "livable" rooms had no visible source of heat. Examples of livable rooms include bedrooms, kitchens and living/dining rooms, NOT hallways, closets or bathrooms. Livable rooms without heat (e.g. heat register, radiator, baseboard or wall heater) can be uncomfortable and have high levels of moisture. Depending on the client's needs, recommend consulting with a qualified heating contractor to determine options for modifying or improving the heating system per standard building practices.

Photo 28-1 No heat source in bedroom

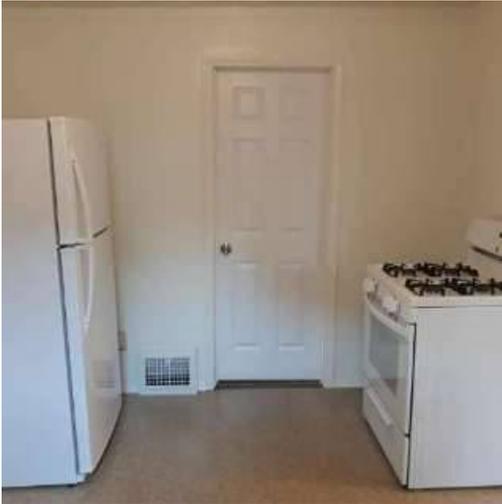
Photo 30-1

No exhaust hood, ceiling or wall-mounted exhaust fan or downdraft exhaust system was found for the cook top or range. This can be a nuisance for odor and grease accumulation. Where a gas-fired range or cook top is installed, carbon monoxide and excessive levels of moisture can accumulate in living spaces. Recommend that a qualified contractor install a venting system per standard building practices.

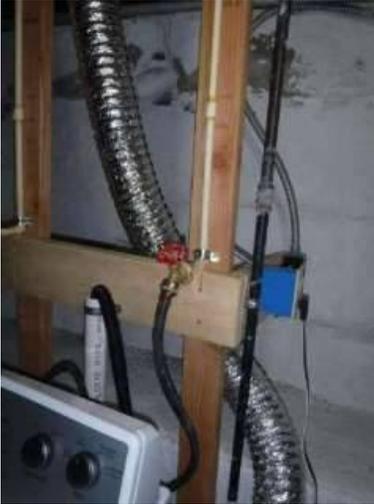
Photo 31-1

The clothes dryer was equipped with a vinyl or mylar, accordion-type, flexible exhaust duct. The U.S. Consumer Product Safety Commission considers these types of ducts to be unsafe, and a fire hazard. They can trap lint and are susceptible to kinks or crushing, which can greatly reduce the air flow and cause overheating. Recommend that such ducts be replaced with a rigid or corrugated semi-rigid metal duct, and by a qualified contractor if necessary. For more information, visit:

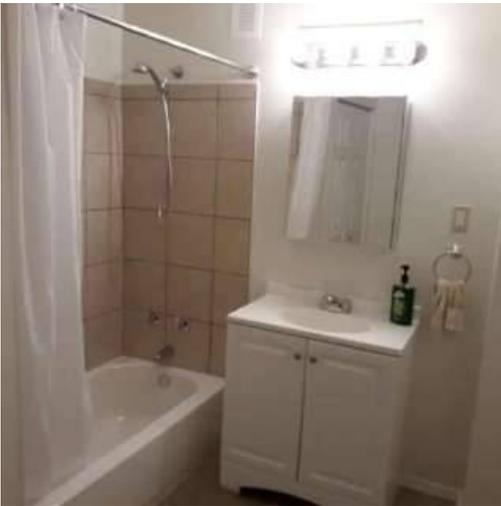
Photo 32-1

The bathroom with a shower or bathtub at location(s) #A and B didn't have an exhaust fan installed. Moisture can accumulate and result in mold, bacteria or fungal growth. Even if the bathroom has a window that opens, it may not provide adequate ventilation, especially during cold weather when windows are closed or when wind blows air into the bathroom. Recommend that a qualified contractor install exhaust fans per standard building practices where missing in bathrooms with showers or bathtubs.

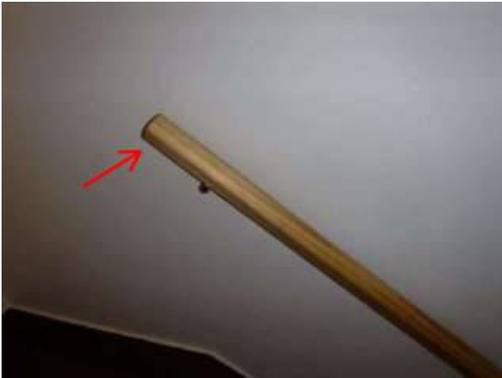
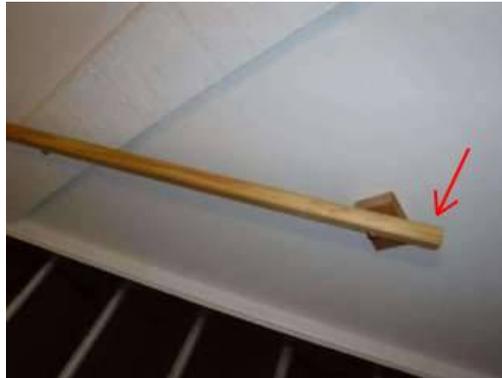
One or more handrails had no returns installed, where ends of handrails turn and connect to adjacent walls so objects or clothing will not catch on the open ends. This is a safety hazard. Recommend that a qualified person install returns per standard building practices.
