Ohio Home Inspection

Property Inspection Report

Client(s): **John Q Public**
Property address: **123 Main Street**
Cleveland, OH
Inspection date: **Monday, September 7, 2020**

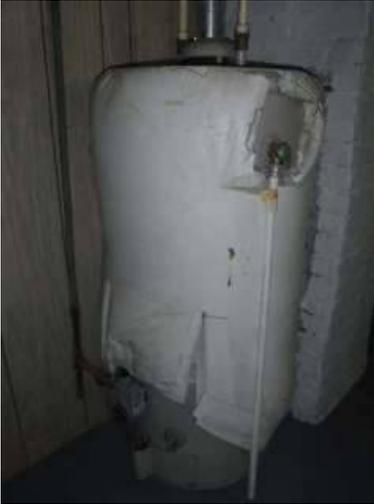
Photo 27-1

If found to be near, at or beyond its useful lifespan, recommend budgeting for a replacement in the near future, or considering replacement now before any leaks occur. The client should be aware that significant flooding can occur if the water heater does fail. If not replaced now, consider having a qualified person install a catch pan and drain or a water alarm to help prevent damage if water does leak.
